CASE HISTORY

98 Cranmer Avenue

Project Details

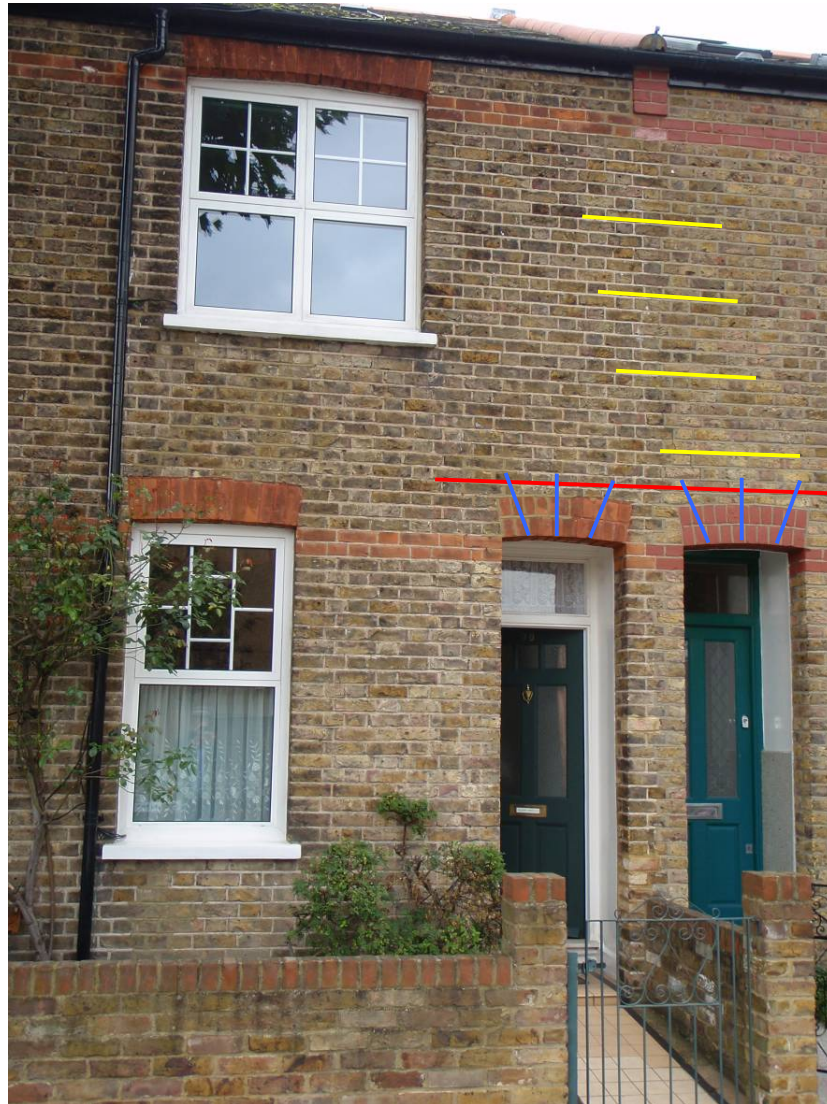
Faulty internal building works in the adjacent property caused structural cracking and defects to occur within internal and external walls to 98 Cranmer Avenue and the adjacent property itself.

HeliBeam continually across the top of the two door openings (Red)

Stitch the brick arch lintels to both property door openings (Blue)

HeliTie crack stitch the front façade with 4 ties (Yellow)

HeliTie crack stitch the internal party wall and return it around to tie into the front façade wall
