OXFORD
HYDROTECHNICS

CASE HISTORY

Client: Network Rail **Duration:** 52 hour possession **Budget:** Within budget

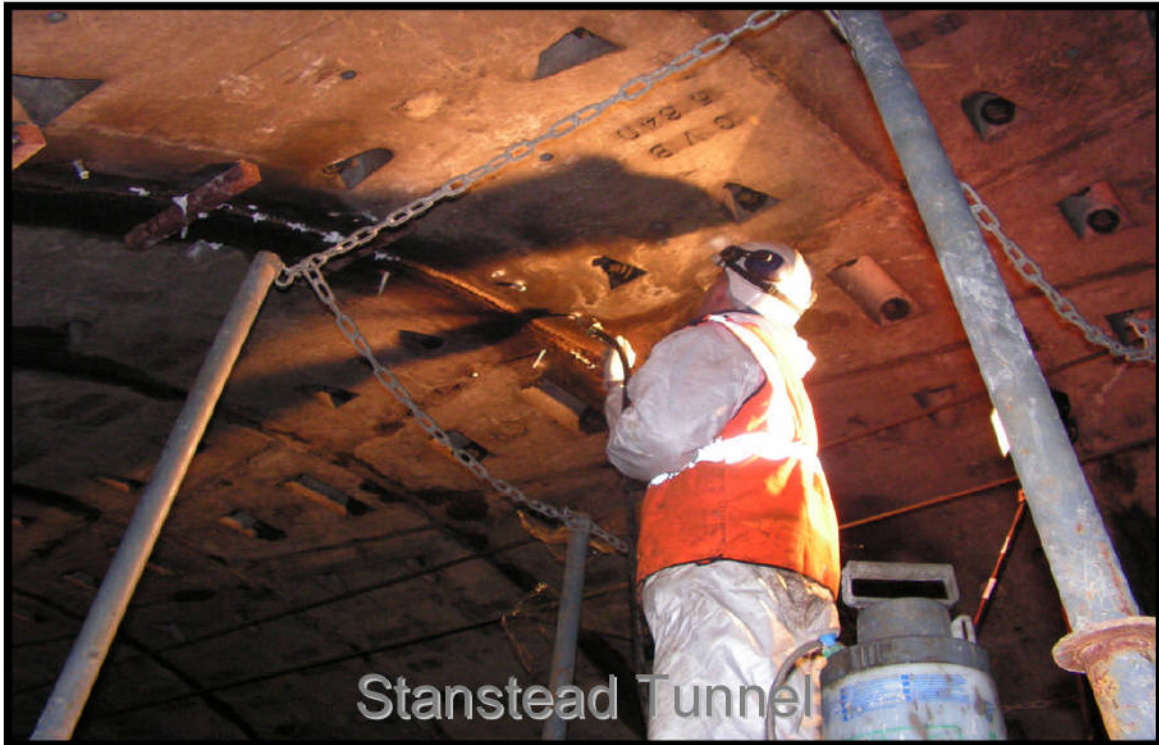
The company has recently worked with Network Rail to find a solution to a water ingress problem within a precast concrete segmental tunnel. The ingress typically occurred through concentric joints between rings. In this particular tunnel the tracks were mounted directly on the concrete base slab and the volume of water was sufficient to bridge the gap between running rails, causing signalling problems outside the tunnel.

Several methods to deal with the ingress over the tracks were used at the time of construction including caulking to joints, and more recently plastic drip trays were installed around the intrados to catch the water and divert it to either side of the track where it could be channelled away in the tunnels drainage channel system. However this solution proved ineffective due to the volume of water; the effect of moving the problem elsewhere within the tunnel and the ongoing maintenance costs.

On examining the problem, OH's engineers decided on a system of resin injection within the leaking joints, using a single component polyurethane resin, which cured to a hydrophobic flexible foam. This flexibility was thought to be of paramount importance to take up the thermal, cyclical and vibration movements typically encountered within a rail tunnel environment.

A 52 hour weekend possession was set aside for a trial of the proposed system and Network Rail selected some of the most problematical joints to give the system a stern test. Network Rail removed the drip trays from the joints and four Oxford Hydrotechnics injection crews were rotated in 12 hour shifts over the weekend. During a 44 hour productive time period, 12 joints were successfully sealed, within the overall works budget, negating the need for reinstating the drip trays.
