OXFORD
HYDROTECHNICS

CASE HISTORY

Kennet & Avon Canal

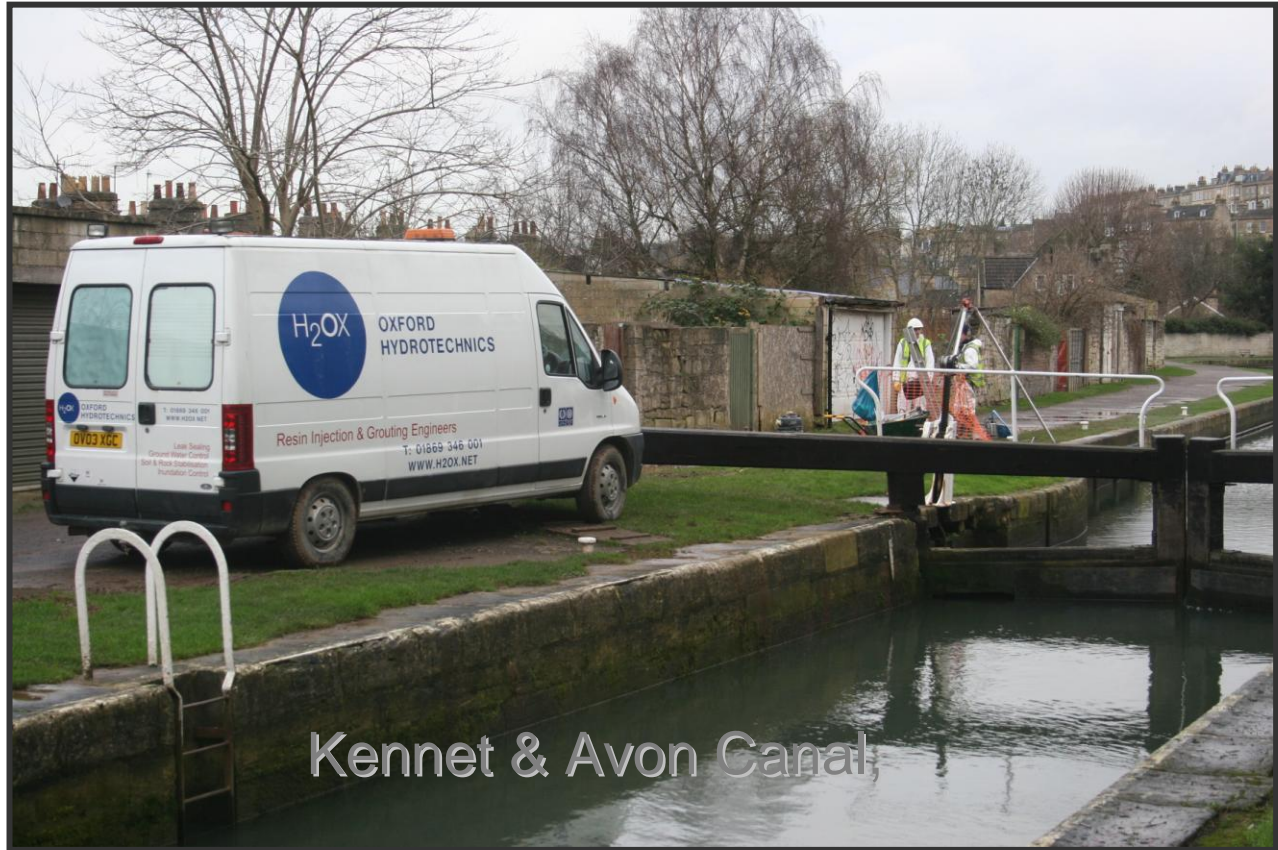
Leakage occurred through the canal wall and around an underground weir chamber adjacent to the lock. This manifested itself with flooding to a residential garden at the rear of the towpath.

H2OX Engineers devised a method of drilling within the weir chamber and vertically through the canal wall to intercept the various flow paths. A fast reacting single component polyurethane was then systematically injected. The flow paths to the garden were sealed within days.
