CASE HISTORY

98 Cranmer Avenue

Project Details

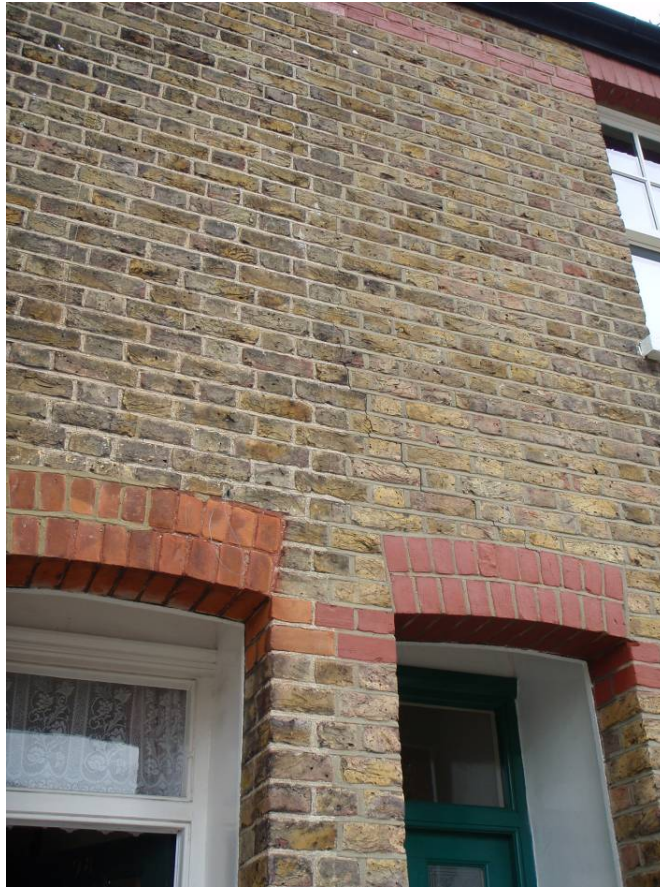
Faulty internal building works in the adjacent property caused structural cracking and defects to occur within internal and external walls to 98 Cranmer Avenue and the adjacent property itself.

H2Ox Engineers carried out a detailed survey of the defects and put forward the Helical Tie structural reinforcement system to tie in each side of the cracks to prevent further movement and opening up. Utilising the manufacturers standard method statements for each different tie, H2Ox were able to rectify the defects within 2 shifts

HeliBeam continually across the top of the two door openings (Red)

Stitch the brick arch lintels to both property door openings (Blue)

HeliTie crack stitch the front façade with 4 ties (Yellow)

HeliTie crack stitch the internal party wall and return it around to tie into the front façade wall
