OXFORD
HYDROTECHNICS

Basement Water Ingress Control

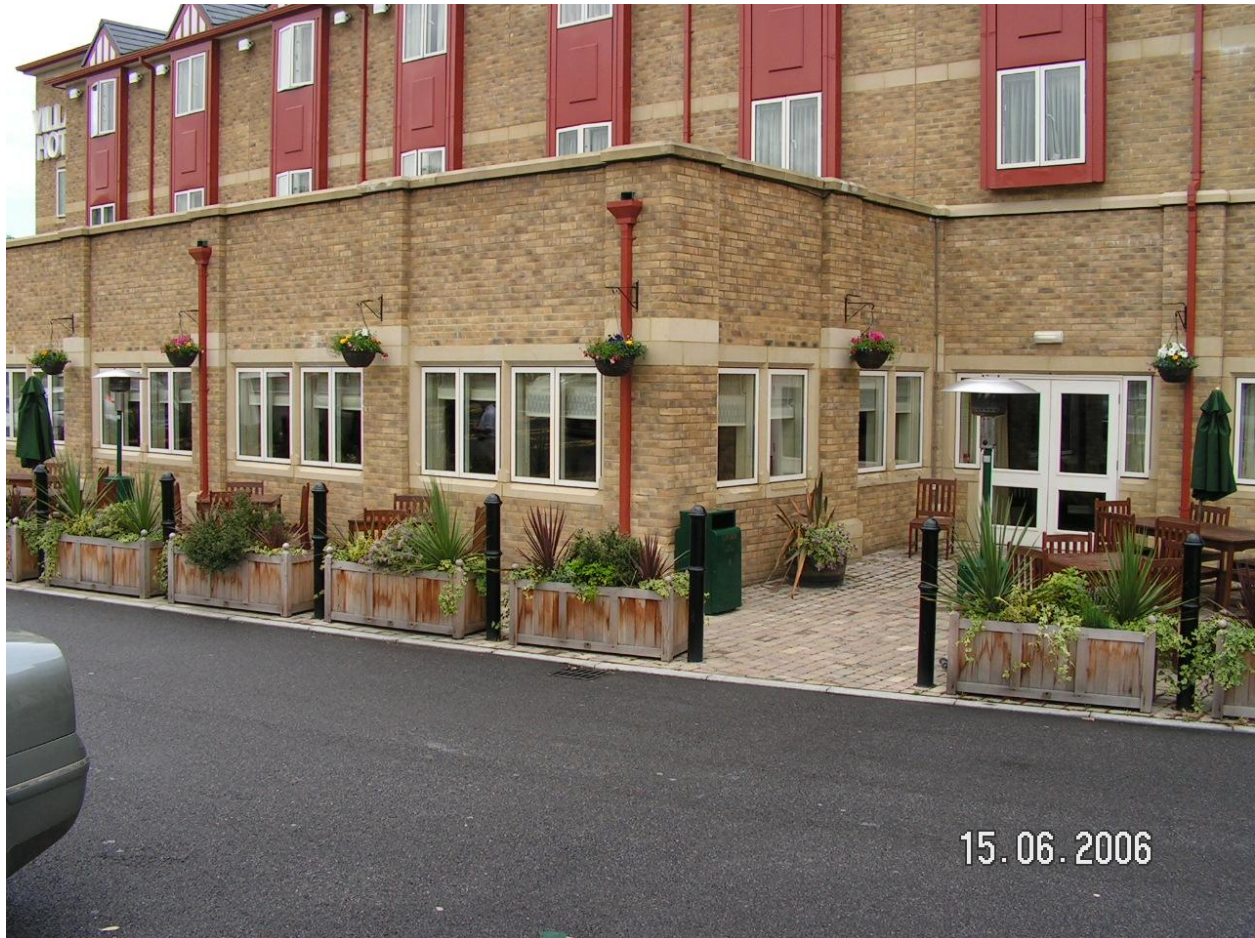
A persistent water ingress problem occurred along the front façade, resulting in rainwater flowing into an underground gymnasium, causing damage to fixtures and fittings. Several attempts had been made to rectify the problem which had existed for several years, including taking up paving and relaying waterproof membranes to the surrounding concrete slabs. However the problem still remained.

H2OX engineers put forward a polyurethane resin injection option to rectify the problem. Water was poured over the paving to activate the leaks in the gymnasium. Water ingress subsequently occurred through joints between structural steel members and the concrete soffit in the gymnasium. H2OX technicians were then able to target these areas and successfully sealed all the leaks in less than a week.
