OXFORD  
HYDROTECHNICS

## CASE HISTORY

Kennet & Avon Canal, Bath

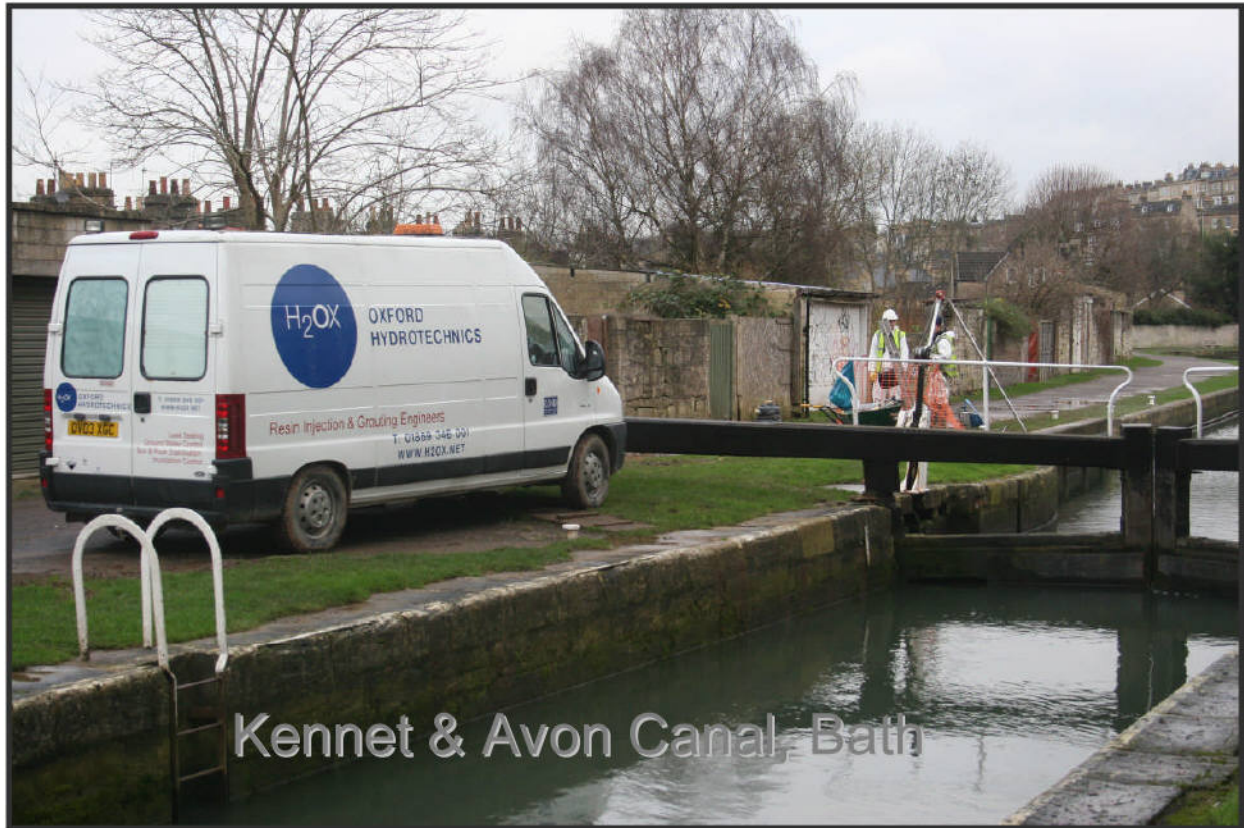
Leakage occurred through the canal wall and around an underground weir chamber adjacent to the lock. This manifested itself with flooding to a residential garden at the rear of the towpath.

H2OX Engineers devised a method of drilling within the weir chamber and vertically through the canal wall to intercept the various flow paths. A fast reacting single component polyurethane was then systematically injected. The flow paths to the garden were sealed within days.
